Post-Retrofit Assessment of  
Lighting & HVAC Conditions in  
Three Tenanted Buildings-  
Liberty - PECO Smart Grid  
Investment Grant Program

January 2013

Post-Retrofit Assessment of Lighting & HVAC Conditions in Three Tenanted Buildings

Liberty – PECO Smart Grid Investment Grant Program

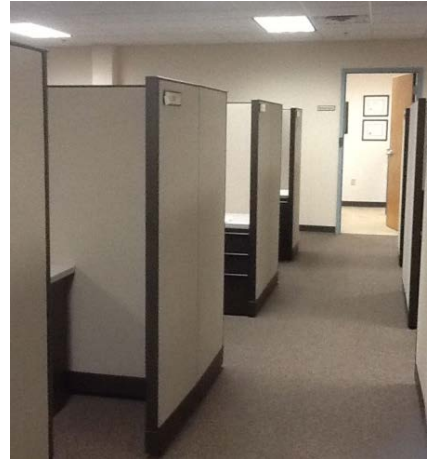
Floor plan changes. In at least two separate office spaces tenants made changes in fit-out that appeared to lack integration with the location of lighting fixtures. As an unintended result, overhead light fixtures were not aligned with occupied cubicles and desk surfaces in a number of cases so that workspaces were not located directly below the light fixtures, leading to inadequate lighting on work surfaces. In some cases, occupants of these spaces reported low lighting levels for their work tasks (see Figure 3).

Figure 3. High cubicles without aligned lighting fixtures in office with no custom fit-out.

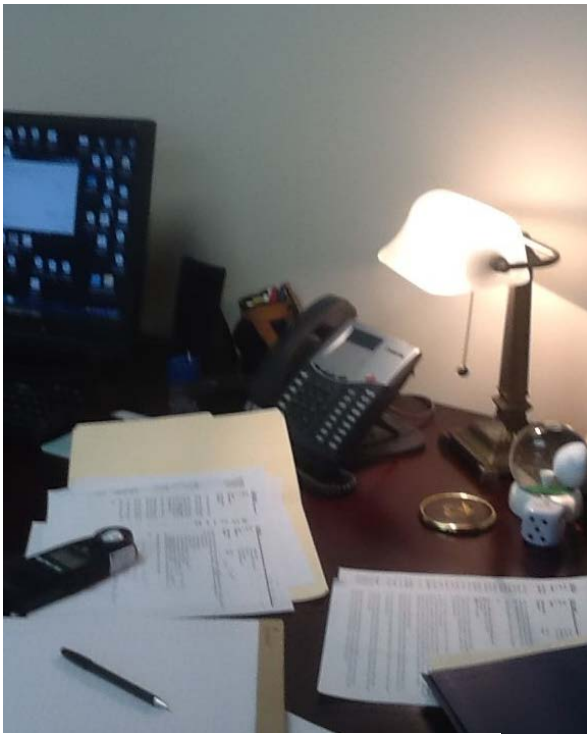
Task lighting. Of the subset of 29 workspaces visited, six had task lighting. Four of these task lights were on while two were off at the time of our visit. Figures 4 and 5 illustrate two different uses of task lighting. Lighting measures were taken both with and without task lights on and again showed variability. On the low end, in one cubicle work space measurement at a desktop work area showed only 260 lux, while a few feet away in the same cubicle, but directly under the cabinet task light, we recorded 310 lux. In another cubicle illuminance was 460 lux without task lighting and increased to 680 lux with task lighting turned on.

Figure 4. Desktop task lighting.

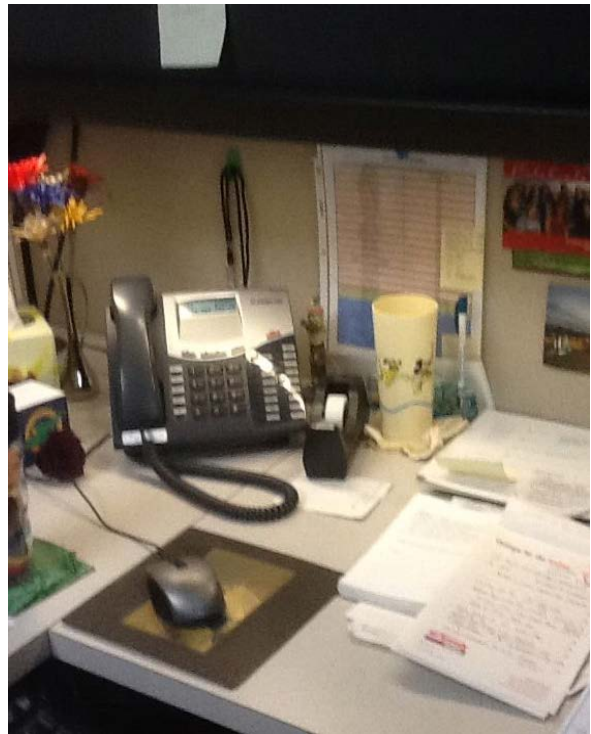
Figure 5. Under cabinet lighting

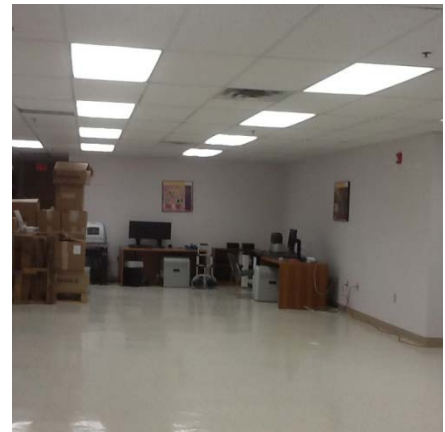
Lighting observations. Of the 31 spaces observed, all of the lights were “on” in 24 of the spaces, while two workspaces had some lights “off”, and 4 workspaces (all enclosed offices) had all lights “off”. There were 102 total light fixtures in these workspaces.

Figure 8. Lights “all on”

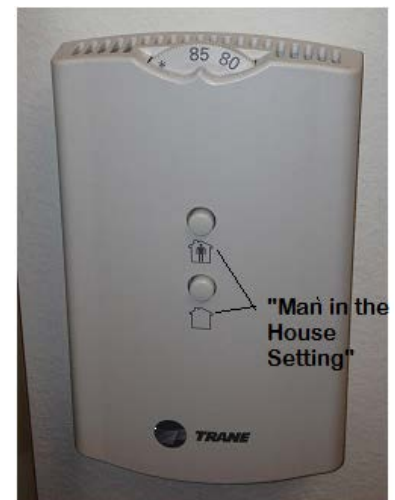
Respondents noted that in some cases air blowers would not shut off. On the day of the site visit some thermostats were set at the highest level, in settings

Figure 9. Thermostat in Building Site 4.

that were noted by the observers to be quite cool (see Figure 9). The “man in the house” feature depicted in Figure 9 is meant to allow changes in temperature settings during non-normal work hours, but has been disconnected. Some occupants thought that local thermostats were neither connected nor operational.

- More user-friendly thermostats might help occupants adjust local temperature settings, reducing the need for portable heaters or fans.
- There is potential to improve energy efficiency and thermal comfort through enhanced window and window treatment performance, especially in the Malvern building. A number of individuals described overly warm conditions near windows in the summer that could be exacerbated when peak load shedding occurs.

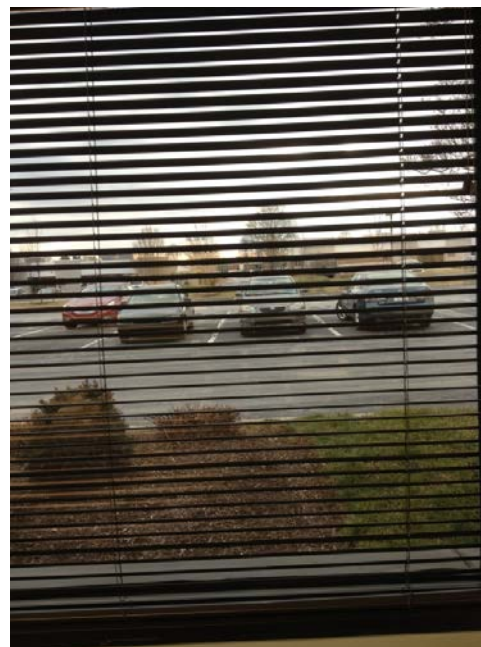
In many of the offices, we observed blinds kept in the drawn position but with the louvers partially open, allowing both privacy and lighting (see Figure 10). In other cases, occupants said that they did not manipulate the blinds at all or relied on other office personnel to do so.

Figure 10. Adjusted blinds

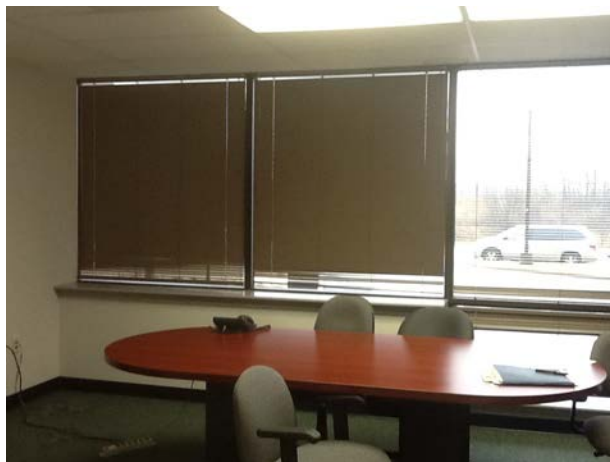
Figure 24. Blinds closed, lights on.

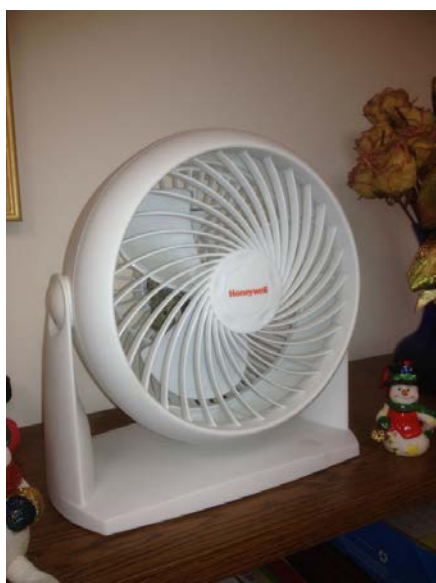
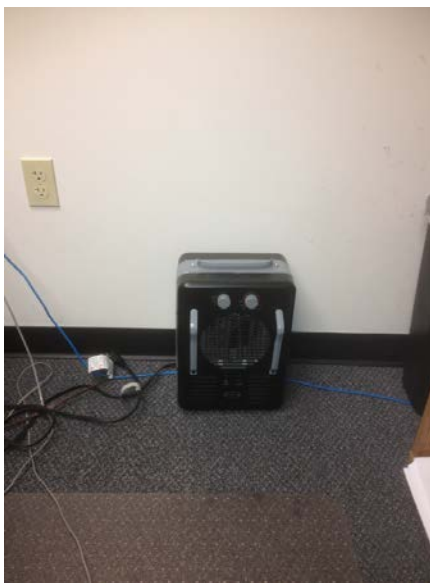
observed thermostats that appeared to have limited functionality, and the use of portable heaters and fans to offset an inability to adjust workspace temperature. These findings suggest that:

Figure 25. Fan at Christmas time Figure 26. Portable heater

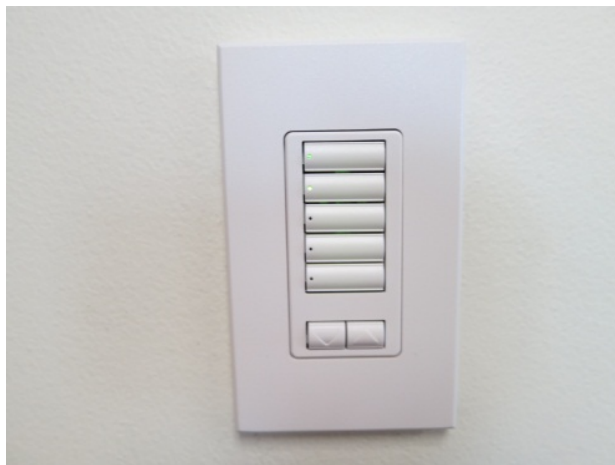
Figure 27. "Don't touch the lights!"

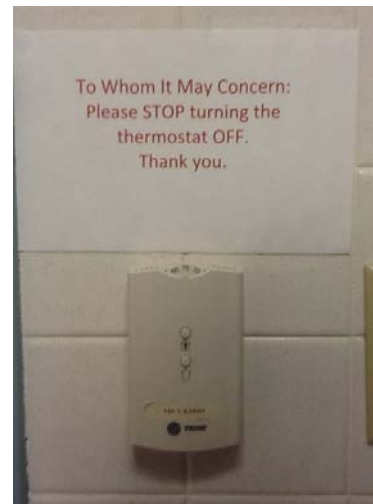
Figure 28. Social Negotiation of thermal comfort

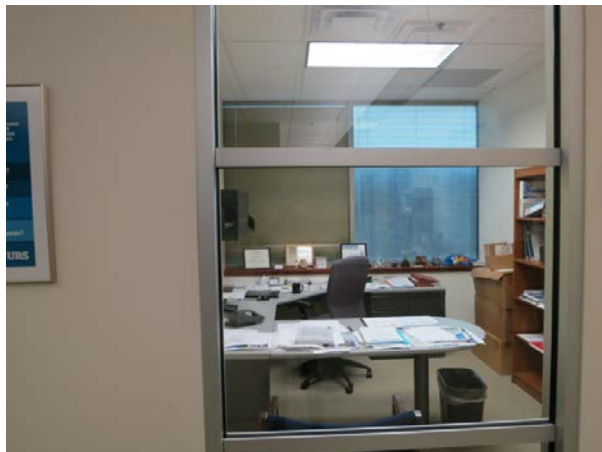
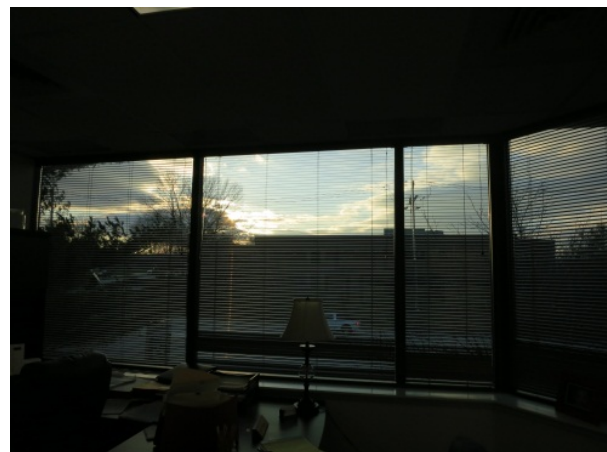
Figures 29 & 30. Unoccupied offices
