Post-Retrofit Assessment of  
Lighting & HVAC Conditions in  
Three Tenanted Buildings-  
Liberty - PECO Smart Grid  
Investment Grant Program

January 2013

Post-Retrofit Assessment of Lighting & HVAC Conditions in Three Tenanted Buildings

Liberty – PECO Smart Grid Investment Grant Program

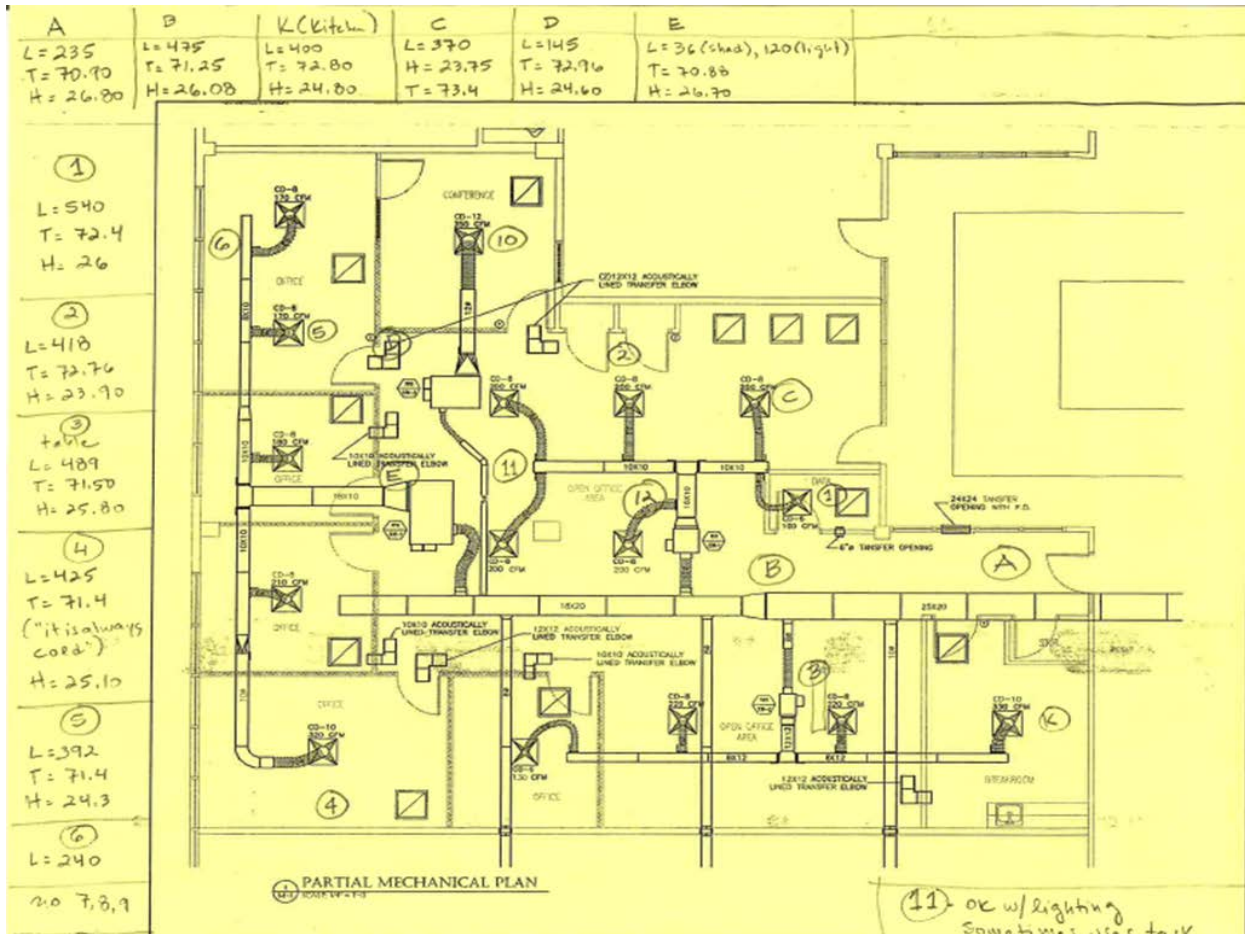
Figure 13: Example of working plan with lux and location measures for post-retrofit site visit. Close up of plan image cropped from original.

- Luminance measures in cubicles and an open “bull pen” area also had a wide range - from 220-920 lux. This compares to the relatively smaller range of the baseline measures (310-600 lux).

Figure 13 provides an example of how a lighting plan was used to measure illumination in one office visited.

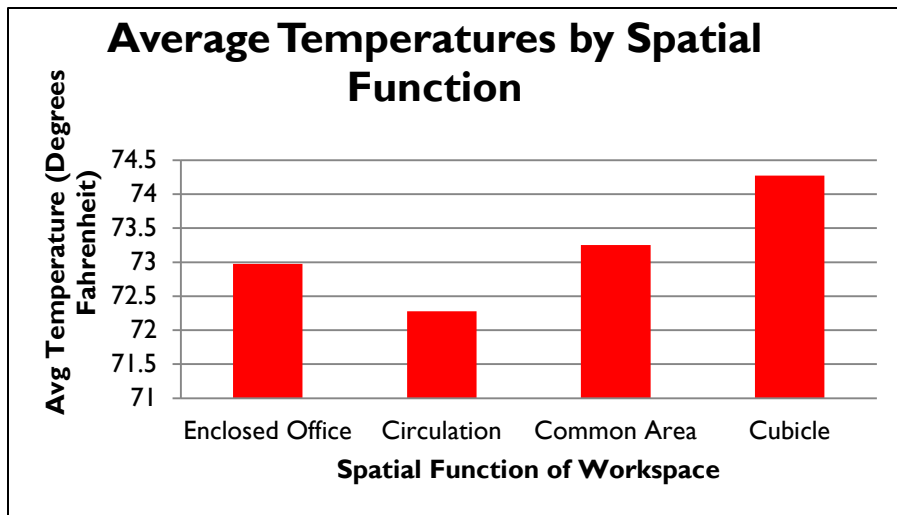
Figure 14. Average temperatures at midday by workspace type, Building Site 3. N=28

- The average temperatures for the three tenants were 72.2 (25%), 73.8 (24.2%), and 75.8 (21.3%) degrees Fahrenheit, with an overall mean of 73 (24.3%) degrees.
- The average temperatures for the four spatial functions were quite similar, ranging from about 72.3 to 74.3 degrees, and the humidity ranging from 22.8% to 24.9%, as seen in Figures 14 & 15.

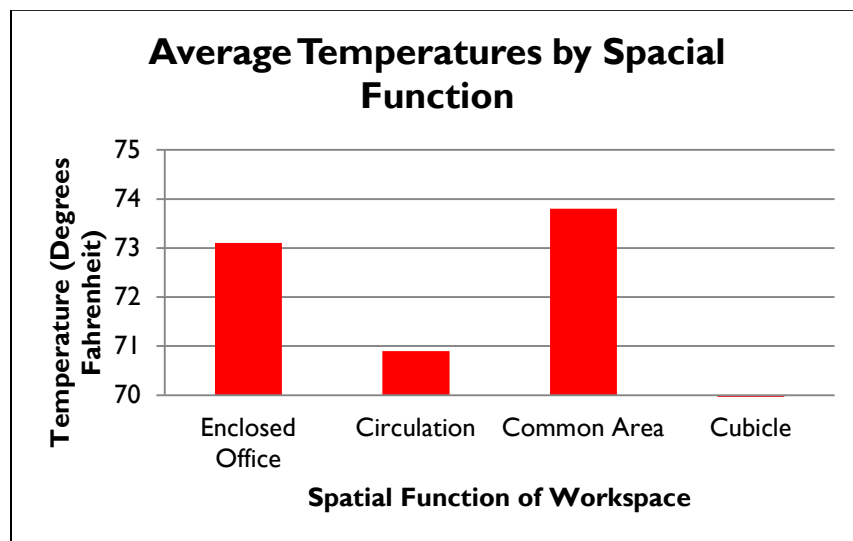
Figure 18. Average Temperatures by workspace type, Building Site 4. N=17

- The average temperatures for the four tenants were 72.6 (19.7%), 73.7 (19.9%), 73.6 (21.2%), and 70.9 (23%) degrees Fahrenheit, with an overall mean of 72.7 (20.9%) degrees.
- The average temperatures for the three spatial functions (cubicle measures unavailable) differed a bit, ranging from about 71 to 74 degrees, as seen in Figure 18. Humidity ranged from 19.9% to 23% (Figure 19).

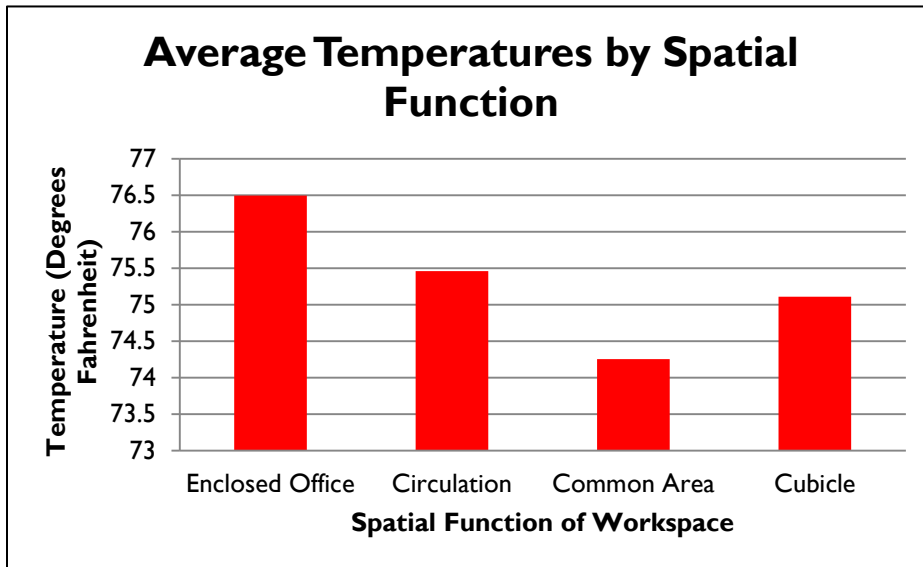
Figure 22: Average temperatures of workspaces, Building site 1. N=57

- The average temperatures between the second and third floor were 74.5 (15%) and 75.8 (17.2%) respectively, with an overall mean of 75.2 (17.8%) degrees.
- The average temperatures for the four special functions were similar, ranging from about 74.3 to 76.5 degrees, with the humidity ranging from 16.4% to 19.4%, as seen in Figures 22 and 23:
